# Memorandum

**Subject:** Report for PCB Sampling of Floodplain Sediments Exposed After Dredging and the Lowering of Water Levels Upstream of the Former Woodside I Dam at the Twelve Mile River

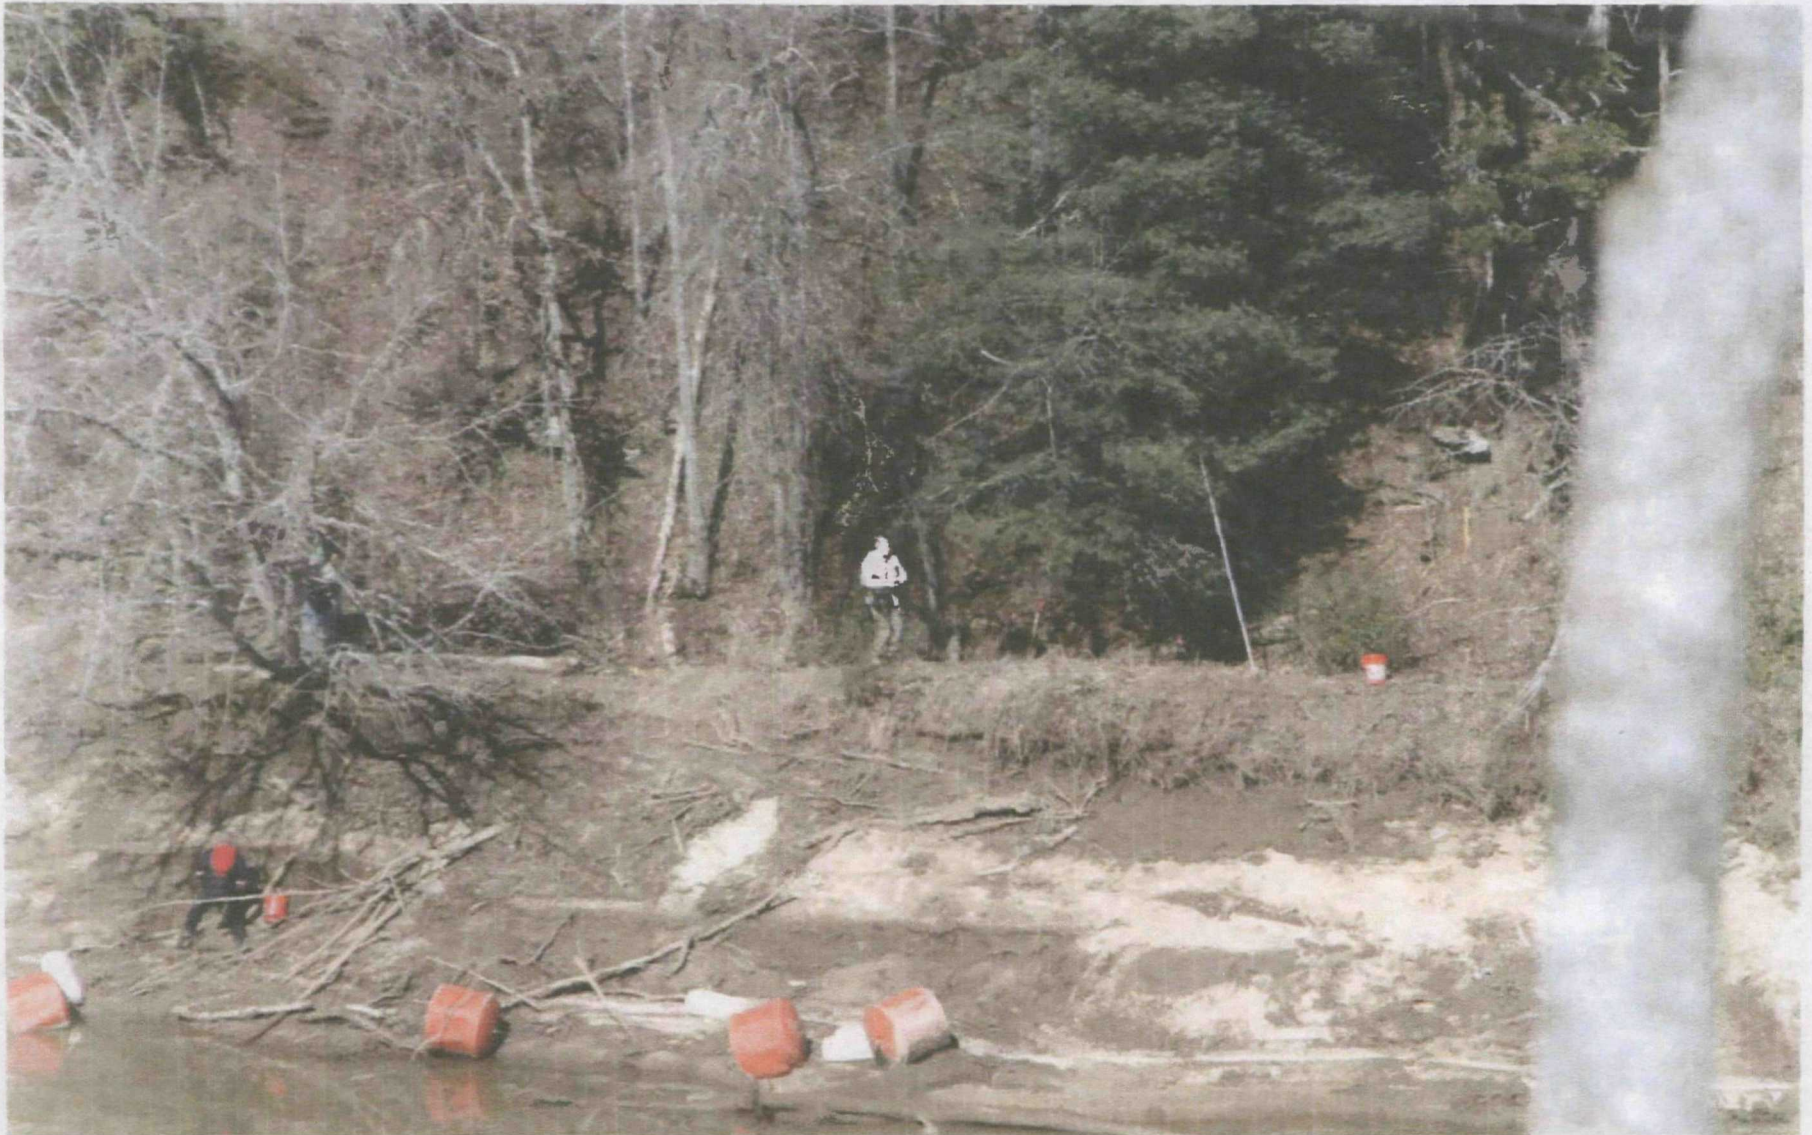
Photo 2: Sediment sampling activities on the north floodplain terrace bank, just upstream of the Woodside I Dam. Sampling focused on the dark, fine grained sediment; sampling visible in the lower left. Photo made Feb. 19, 2011

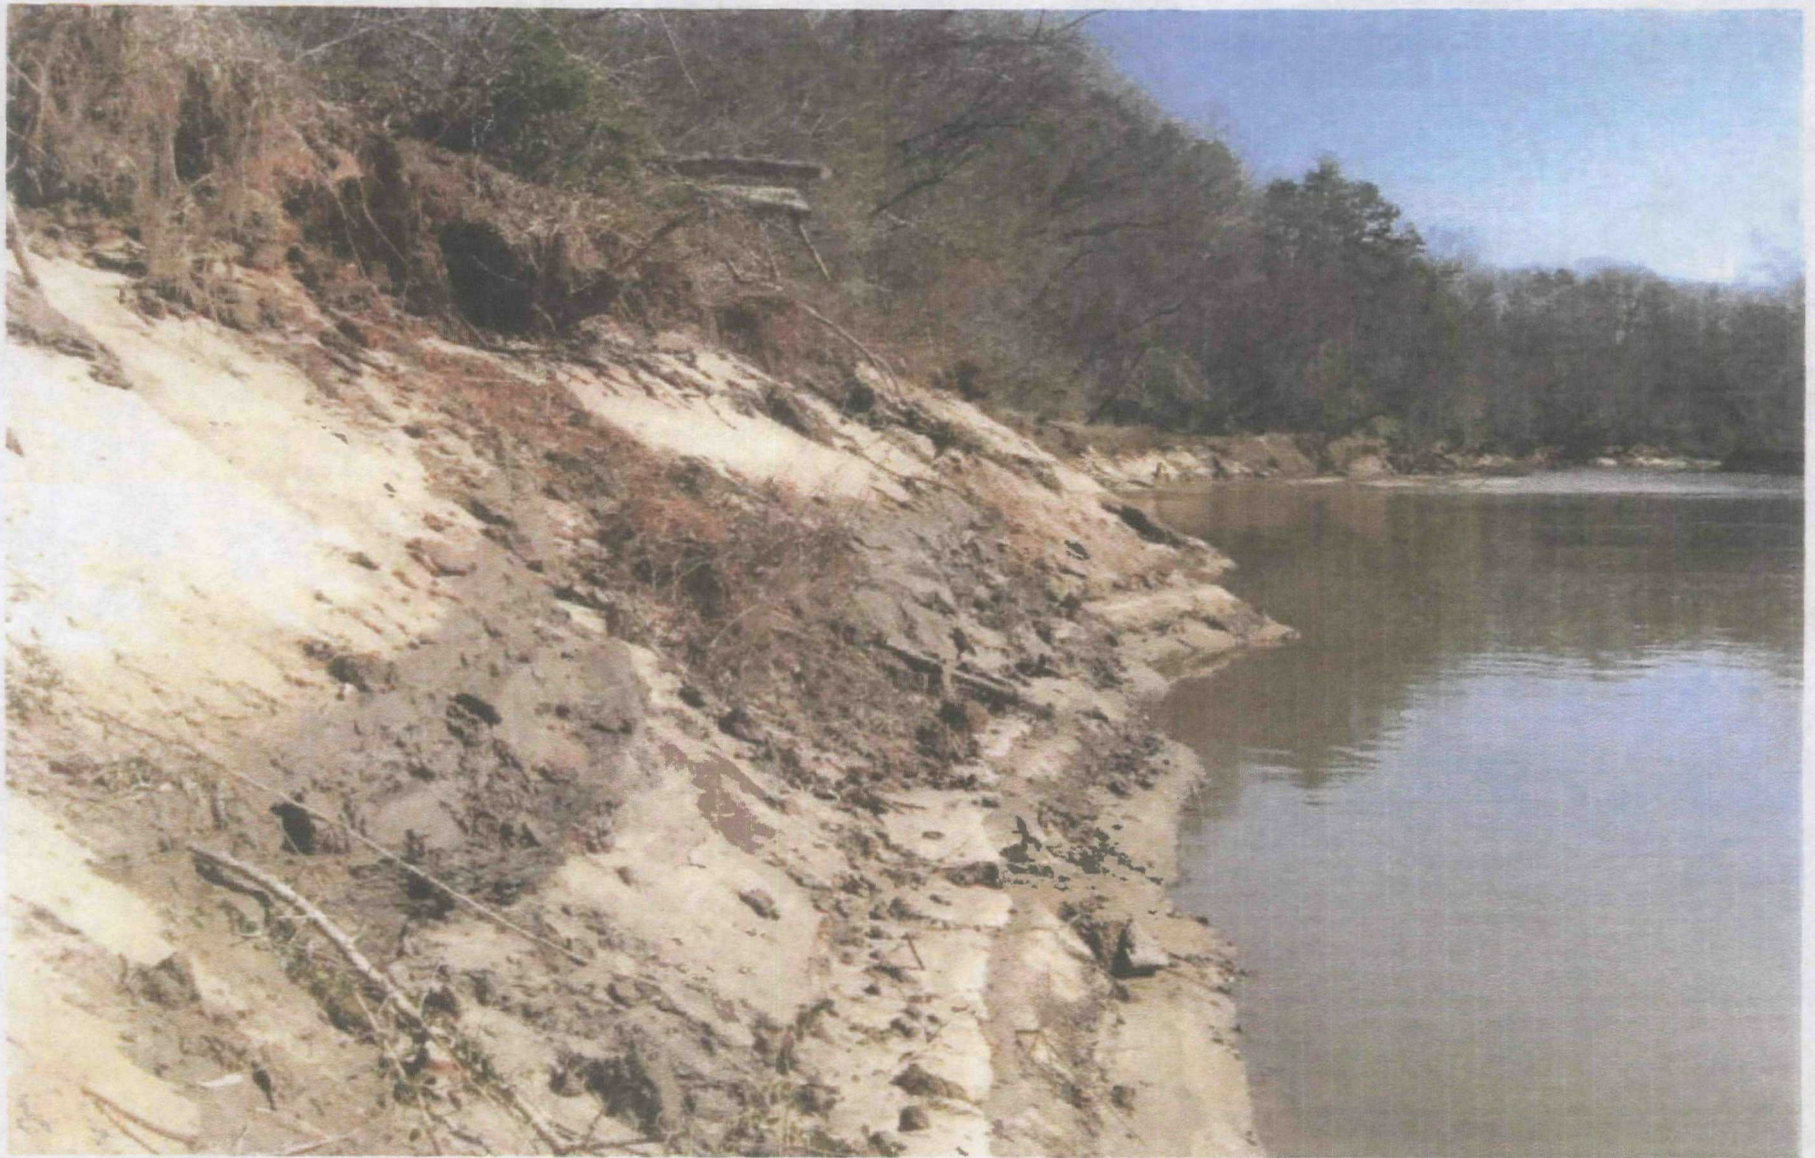
Photo 3: Bank along the north floodplain terrace, located just upstream of Woodside I Dam; note the dark, fine grained sediment layer located within sandy (tan) bank. Photo taken Feb. 19, 2011.

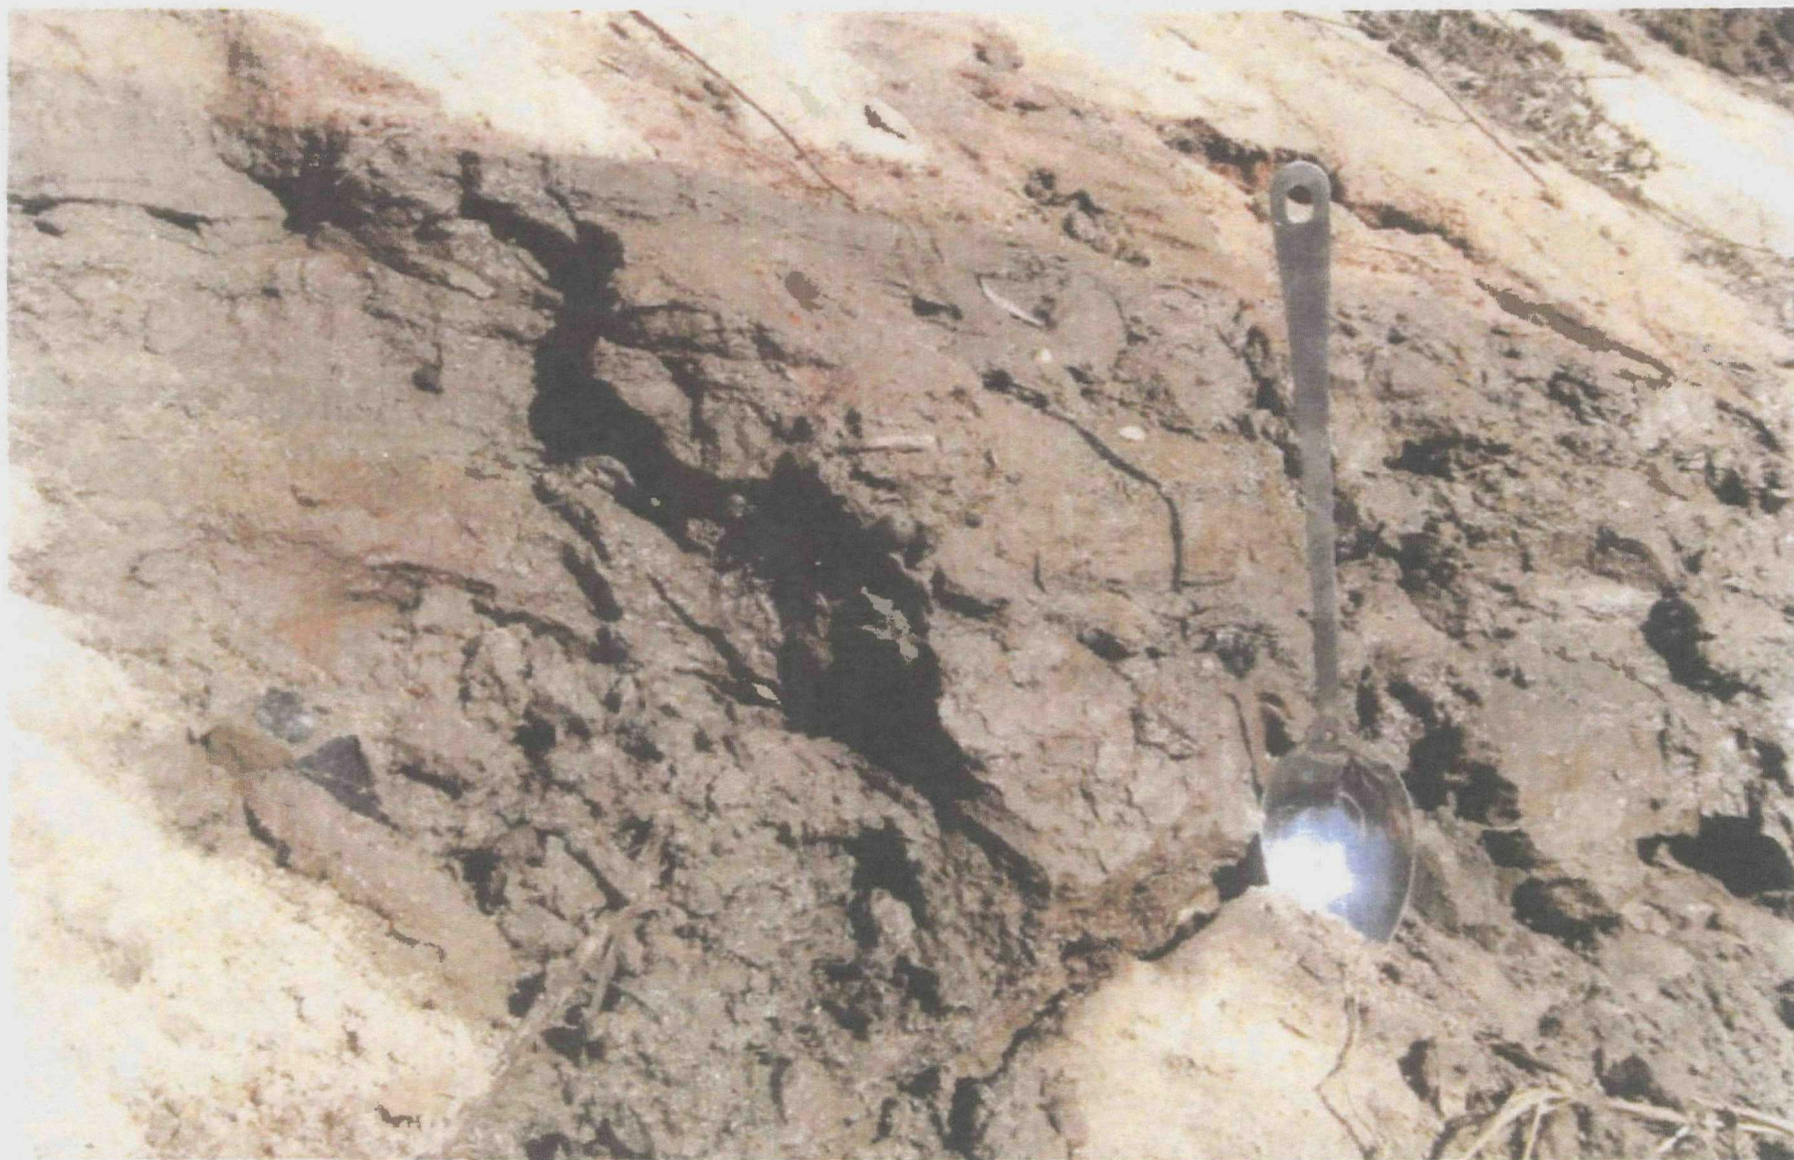
Photo 4: Bank along the north floodplain terrace, located just upstream of Woodside I Dam; stainless steel sampling-spoon is adjacent to fine grained sediment that was sampled for PCBs. Photo taken Feb. 19, 2011.

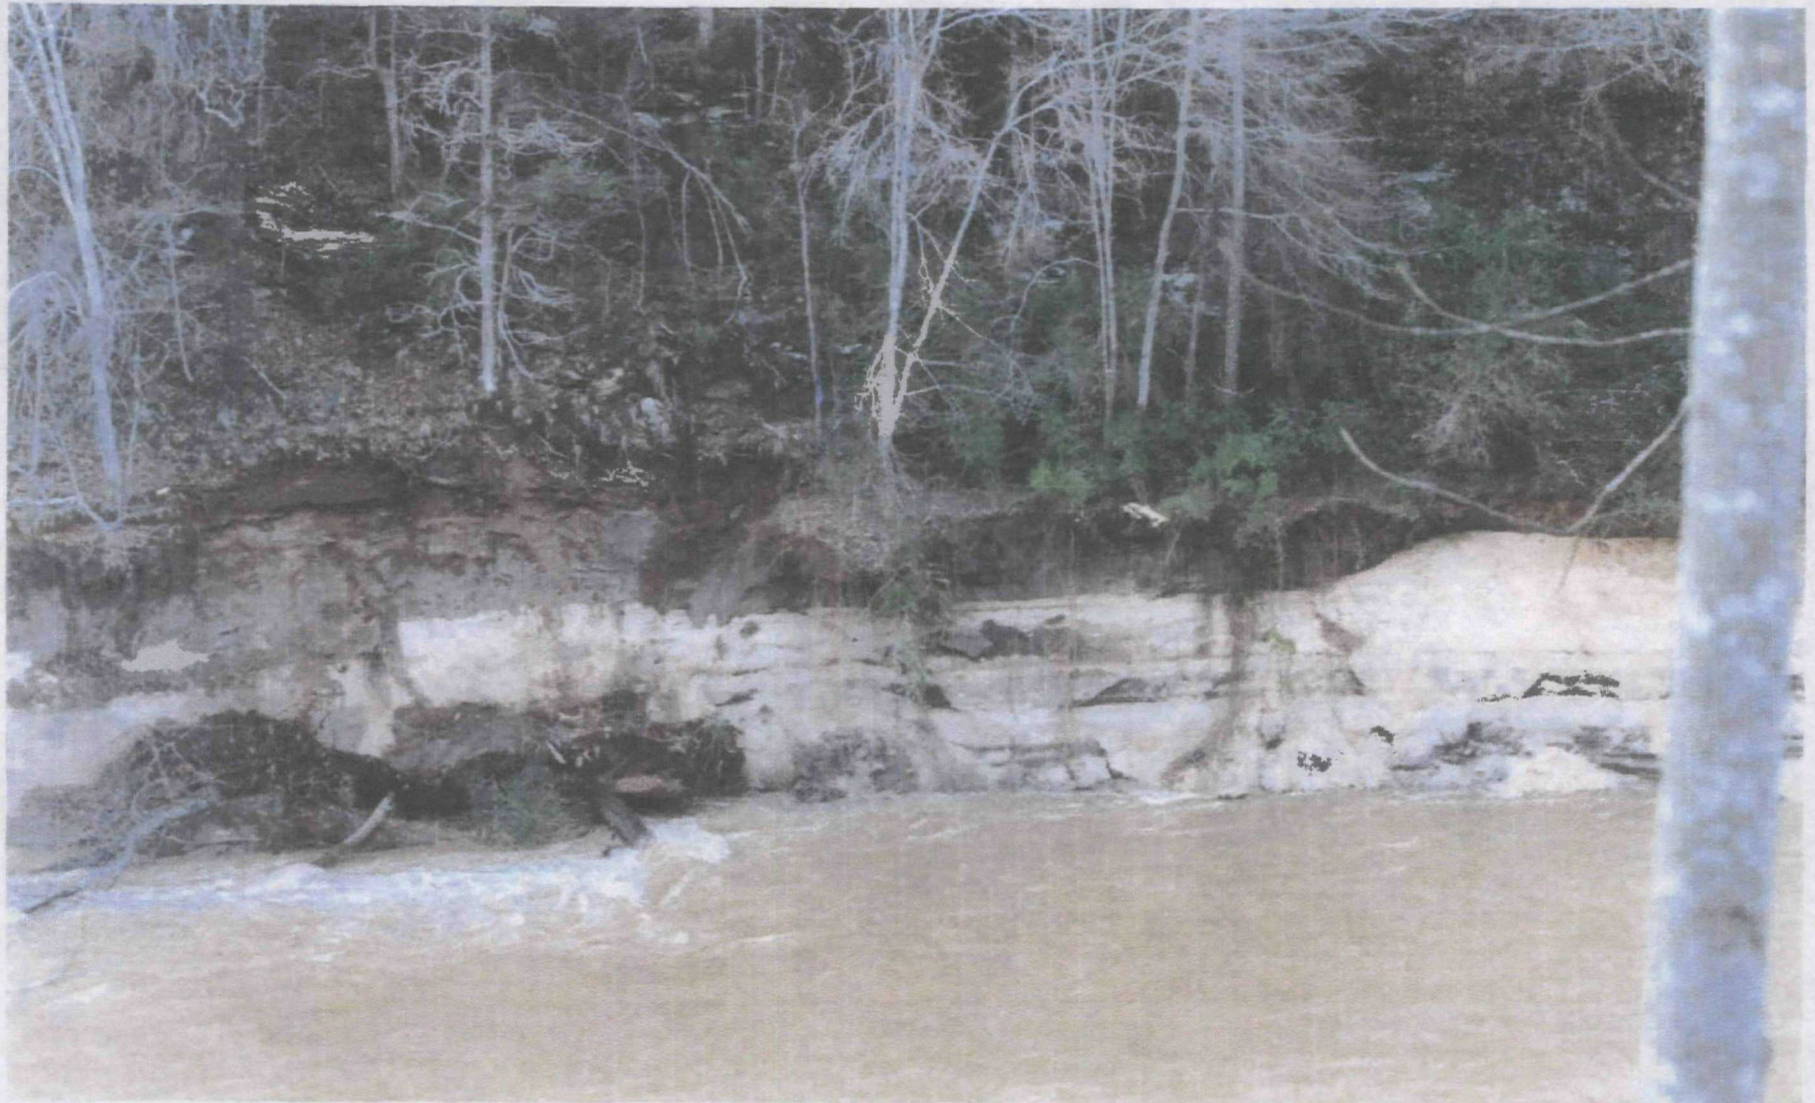
are eroding rapidly as water levels change in the un-impounded river. These photographs combined with the sampling results clearly indicate that significant quantities of PCB-laden sediments have not been removed from the river and that PCB-laden sediments have mobilized downstream, possibly into Lake Hartwell.

Photo 5: Bank of north floodplain terrace, located just upstream of Woodside I Dam. Force of the river following heavy rain has undercut the sandy bank causing the upland plateau to collapse into the river. Strata sampled on Feb. 19, 2011 have washed away. Photo taken on March 16, 2011.

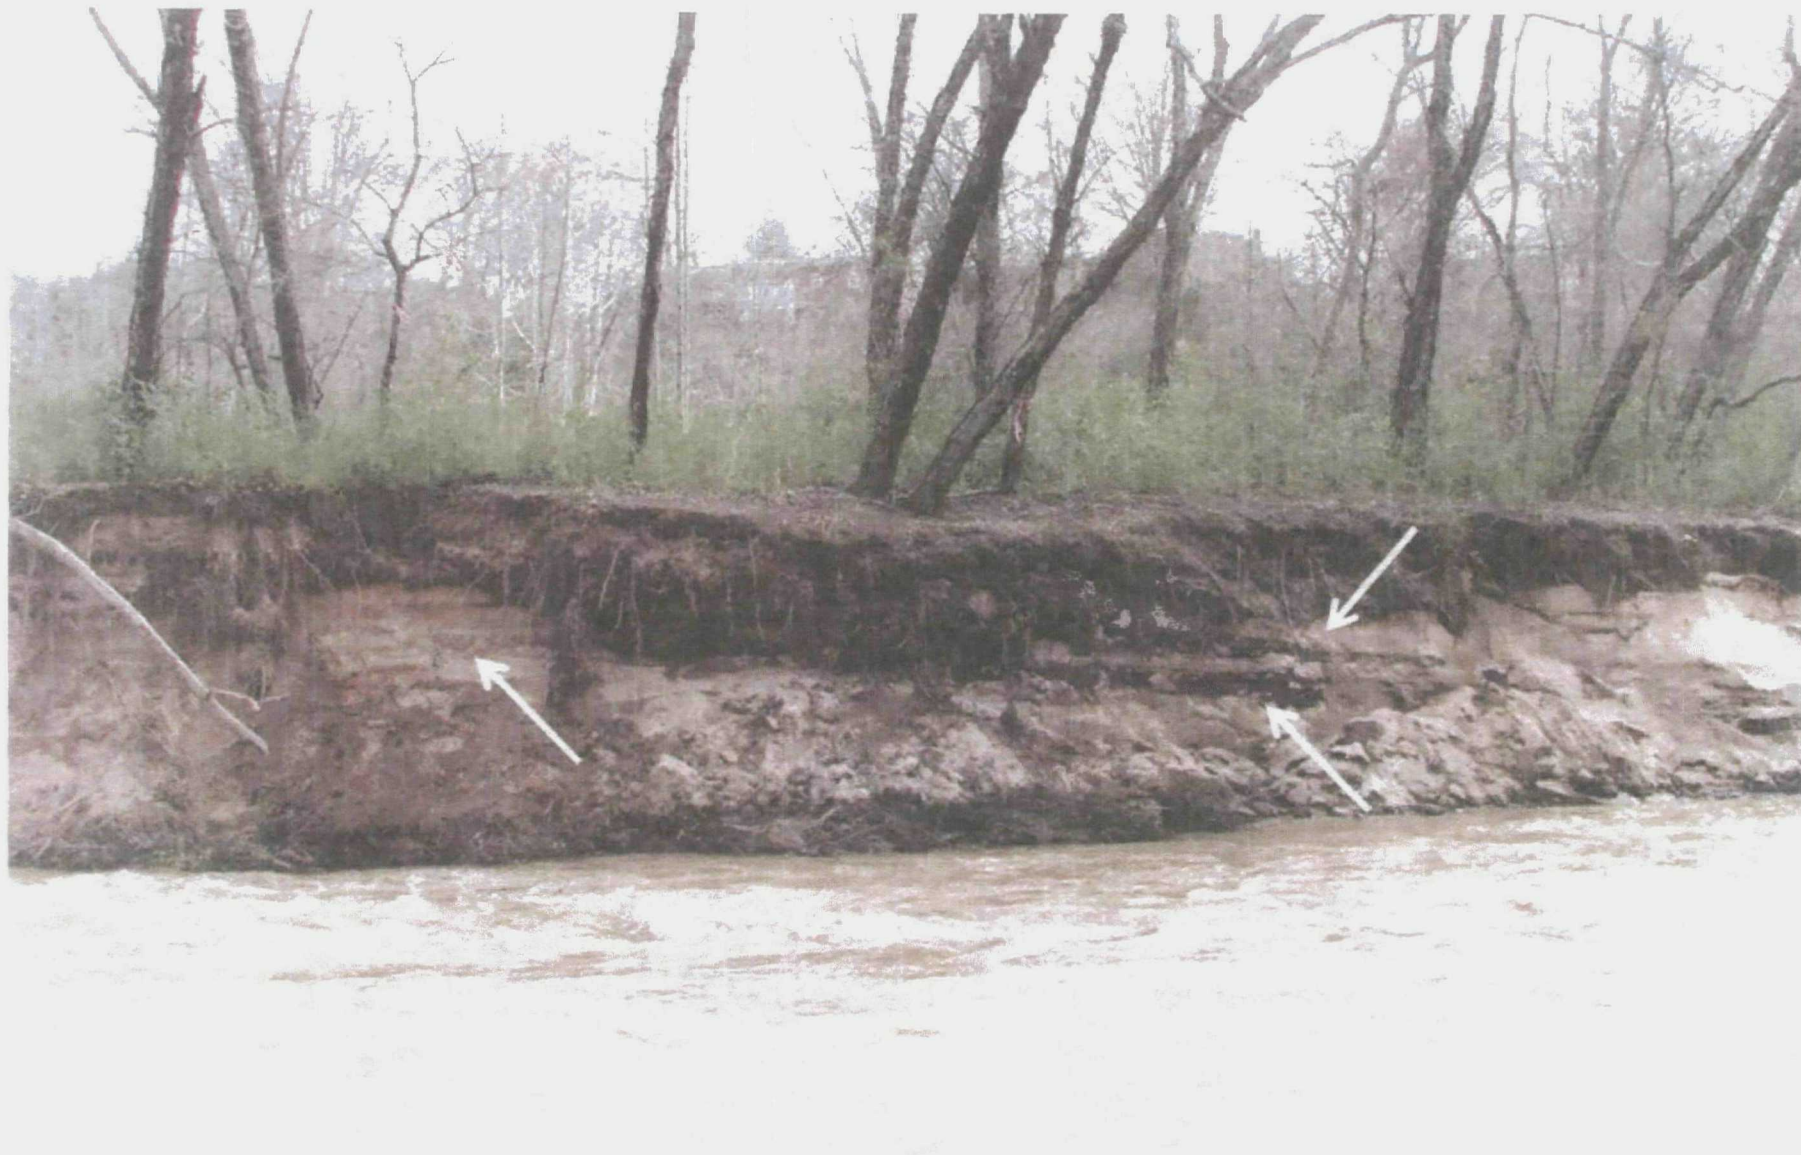
Photo 7: View of river behind Woodside I Dam, after the dam has been removed. The exposed bank from the large south floodplain reveals dark strata (arrows). Strata are similar in appearance to those sampled for PCBs. Photo taken March 17, 2011

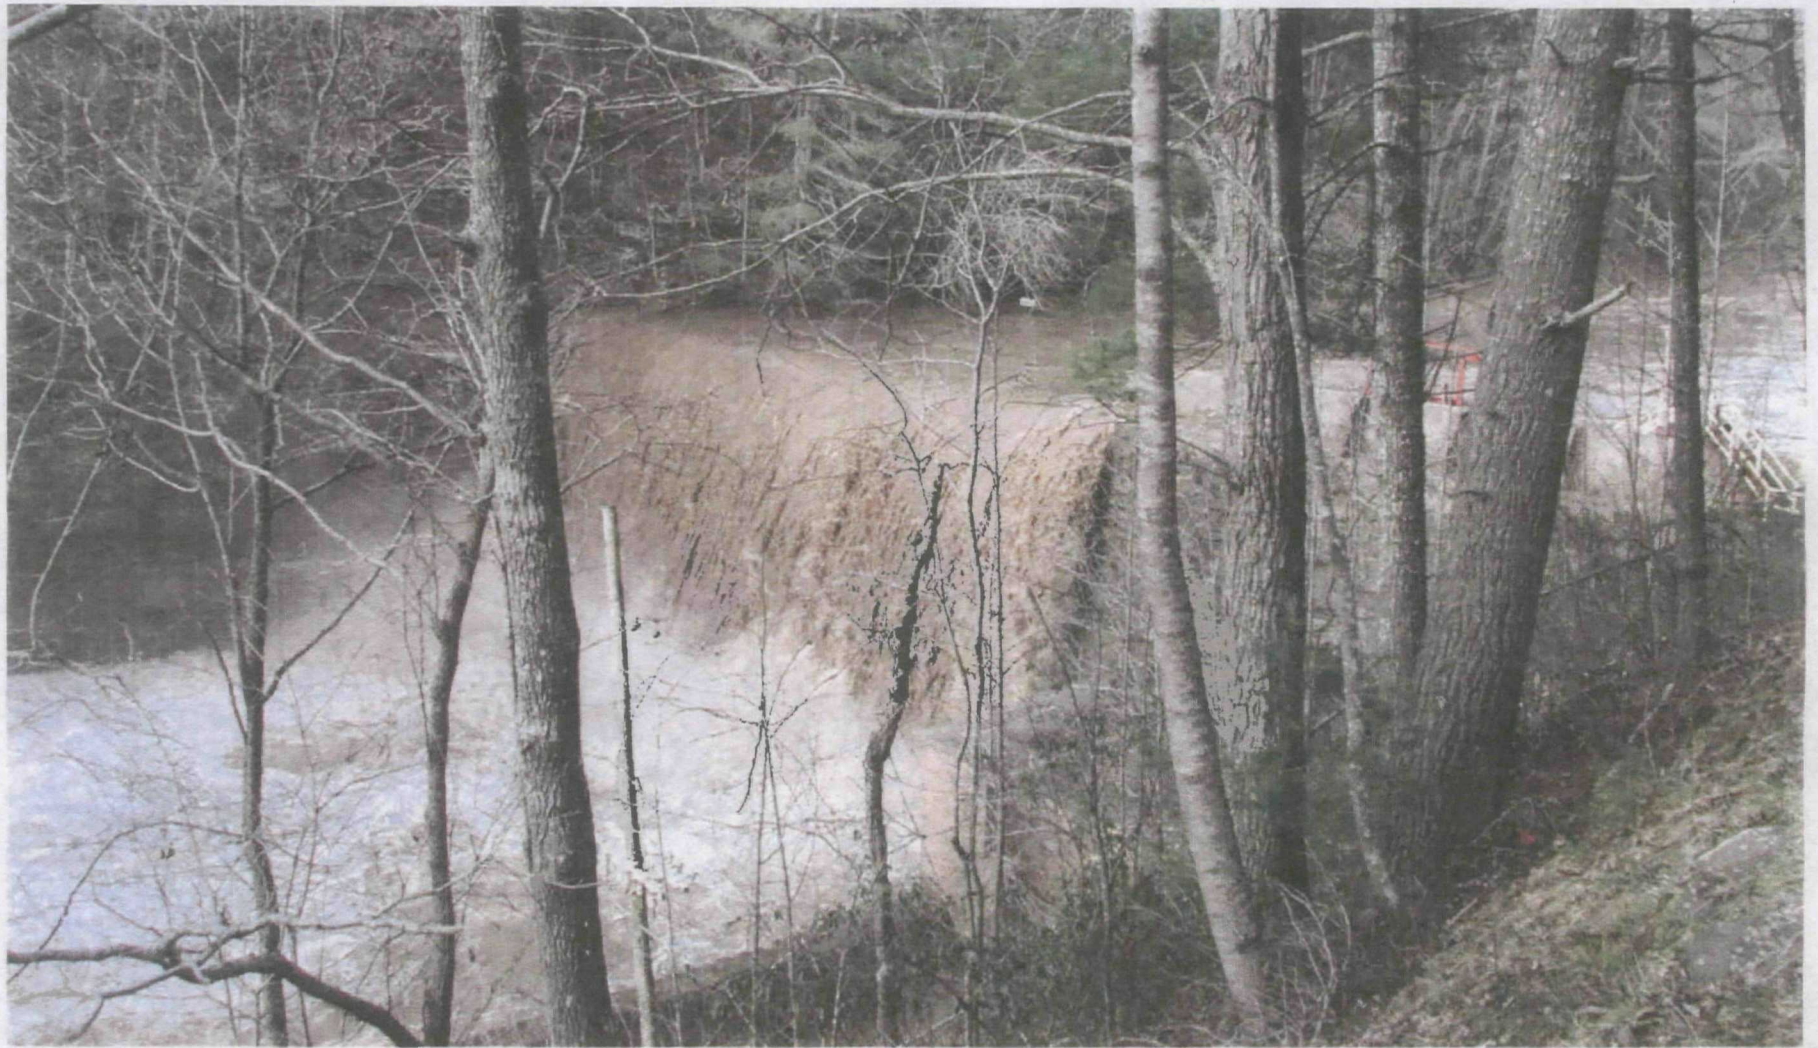
Photo 8: View of water leaving the project boundary, passing over the Woodside II Dam. Water contains an unusually heavy sediment load. Much of the sediment load is from upstream of Woodside I. It represents scour of residual sediment left in the river channel after dredging was terminated and erosion of the floodplain banks exposed after the dam was removed.
